THE DYNAMICS OF A VERTICAL PUMP

By Tom Spettel
Customer Training Manager

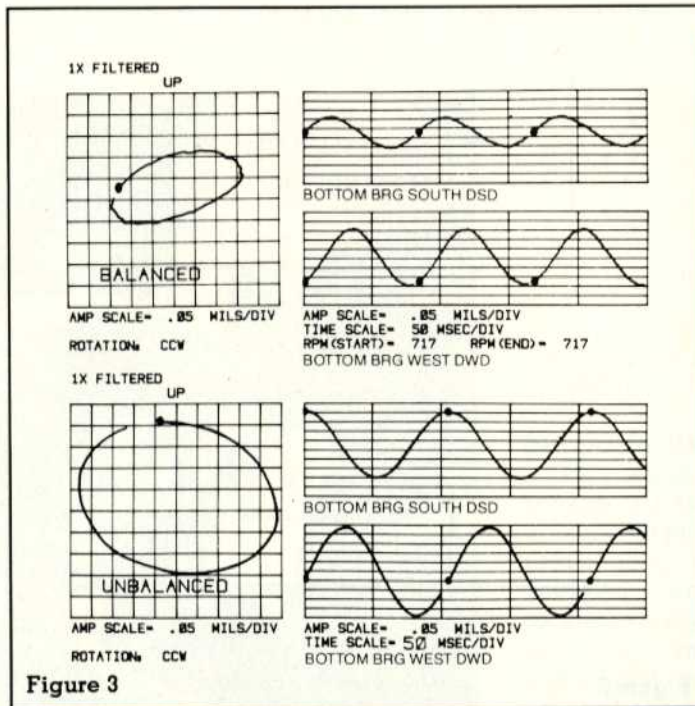
Figure 3 shows the orbit and time base plots of shaft motion with and without the imbalance weight. These measurements were taken at the lower bearing (location D). Note that the plots clearly show the effects of unbalance. Similar plots at the upper bearing (location B) do not show a significant change.

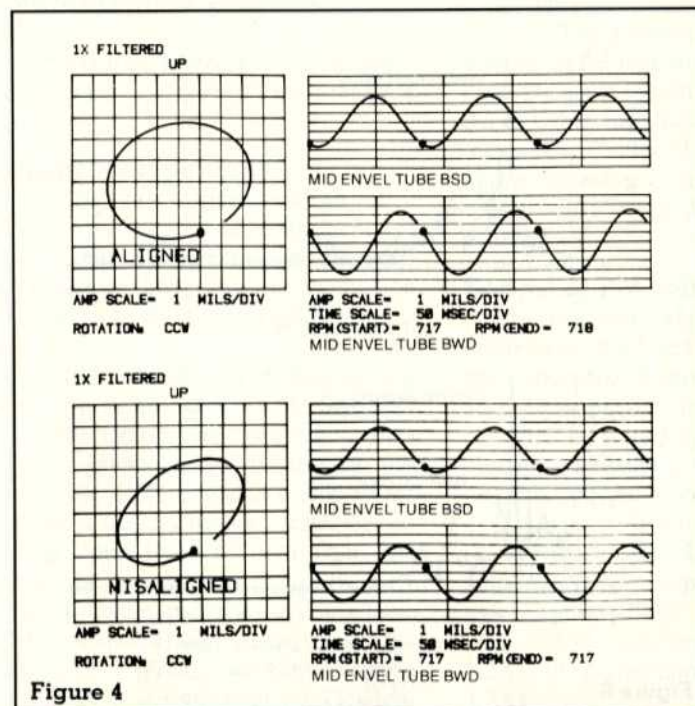
Figure 4

Orbit and time base plots of shaft motion at location B are shown in **Figure 4**. The elliptical shape of the orbit indicates a preload caused by the misalignment. Shaft misalignment is not apparent in the spectrum plots of the same data (**Figure 5**). Since the misalignment manifests itself as 1X vibration, no strong indication of traditional 2X vibration is indicated on the spectrum plot. The preload was not as apparent at the bottom bearing, as expected.

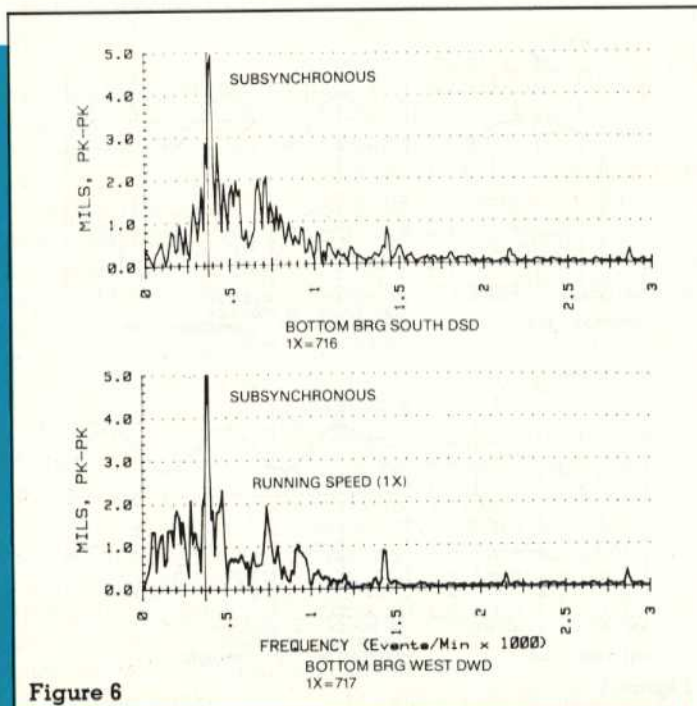
Figure 6

With design clearance, spectrum plots of shaft vibration data from the lower bearing show strong subsynchronous response at 372 cycles per minute (**Figure 6**). This frequency is the first bending natural frequency (critical) of the pump shaft. When the clearance was increased, the subsynchronous vibration became less stable and occurred over a broader frequency range.

The hydraulic response testing determined that the re-excitation of the first balance resonance by the subsynchronous vibration was the cause of the recent shaft failures. These failures were identified by metallurgical analysis as bending fatigue failures.

The answer to these questions was discovered by researching the maintenance records. It was found that the start of shaft failures was preceded by a change in impeller supplier. Recent impellers were not purchased from the original equipment manufacturer (OEM), but from another vendor. The OEM has since indicated that subtle changes in the blade attack angle could cause the re-excitation of the first bending natural frequency (critical) due to vortex shedding.
