Case study: Middle East

VACS system cleared debris from PBR, maintained lower completion in wellbore, saved over \$300,000 USD

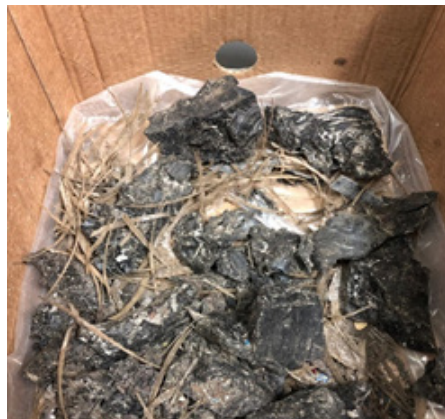
Retrieved pieces of rubber and fiber flakes from the first run proved ID of PBR clogged with debris.

The Baker Hughes team deployed the VACS G2 system into the wellbore but faced an immediate challenge: the outside diameter (OD) of the VACS equipment was larger than the ID of the PBR. Nevertheless, the team ran the entire bottomhole assembly (BHA) to 1 ft (0.3 m) above the PBR and circulated. An analysis of the recovered debris revealed large chunks of annular rubber and fiber flakes had clogged the diverter tube.

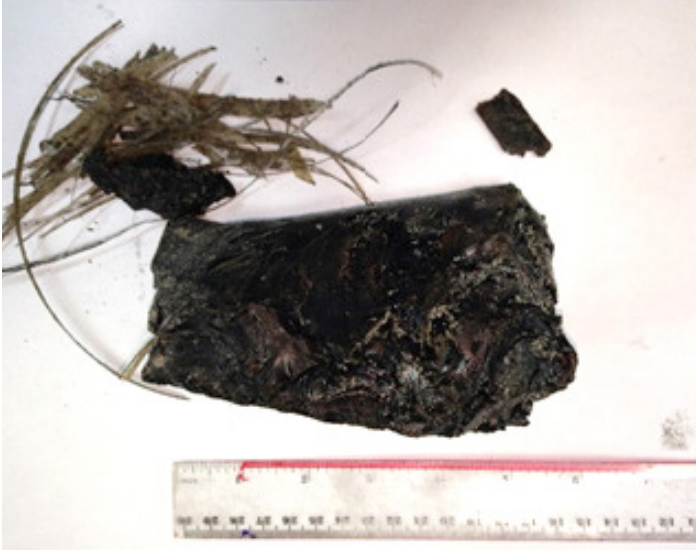
In the second run, larger rubber pieces (up to 6 in.) were pulled from the PBR via the VACS G2 system.

After re-evaluating the downhole situation, onsite personnel removed the diverter tube from the BHA for the second run but included a globe junk basket in order to collect the larger rubber chunks and clear the ID of the PBR. This run yielded additional pieces ranging from 6 in. to 3-1/2 in. The third run returned the diverter tube to the BHA and recovered only small pieces of rubber and fiber flakes. To verify the wellbore was clear of all debris and ready for stabbing, the customer tripped in a successful dummy run.

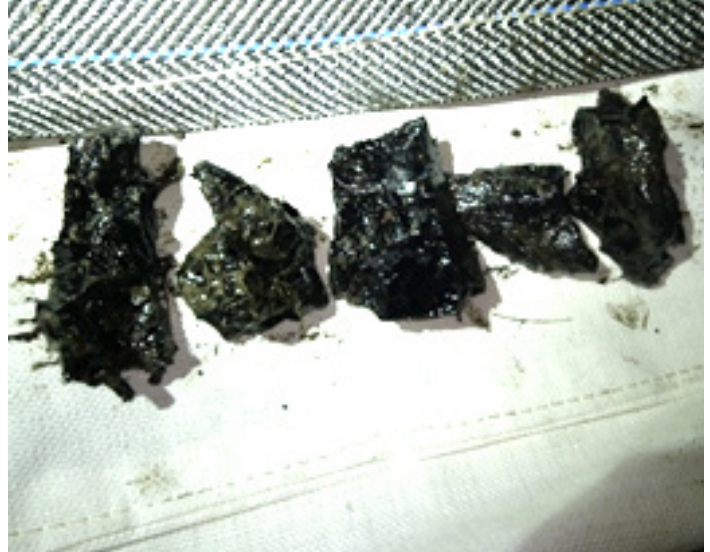
Small pieces of rubber and fiber flakes retrieved in the third run prompted the Baker Hughes team to perform a dummy run to determine if ID was free from debris and ready for the upper completion stabbing.
