PROCESS & PIPELINE SERVICES

Managing corrosion and metal loss

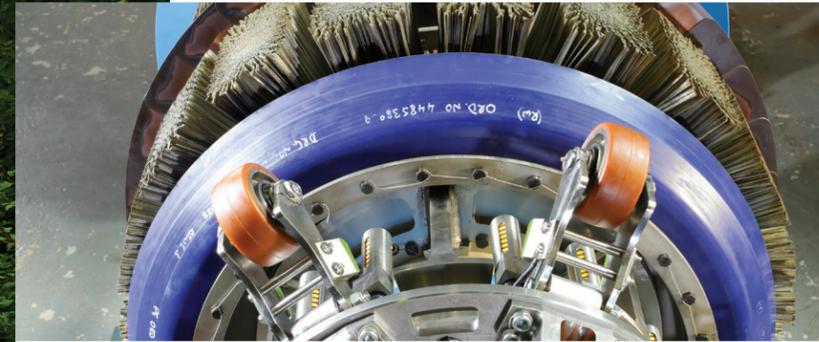
Heavily corroded and difficult-to-access pipelines

VECTRA GEMINI HD, UltraScan™ WMP, and MagneScan™ SHRP are our highest-specification in-line inspection tools. They deliver the best possible information to address your most complex challenges—enabling more reliable decision-making, ultra-high confidence, and significantly fewer digs. VECTRA HD has twice as many sensors as other MFL tools. The result is a more accurate picture than ever before—one that enables early detection and pinpoint accuracy of even the smallest instances of metal loss and complex corrosion. MagneScan SHRP has 4-in-1 sensor technology that makes it possible to identify linkages between individual pits/pinholes and the formation of NAEC as well as circumferential slotting and grooving. UltraScan WMP has more than doubled the number of sensors, which enables detection of defects as small as 5 mm in diameter. These three tools deliver extremely high accuracy for depth, length, and width—making them particularly well suited to lines with extensive complex corrosion, high failure consequences, or the likely presence of axial defects or pinholes. The end result is the high confidence needed to only dig and repair what is absolutely necessary—the savings here significantly outweigh the incremental cost of the higher-specification inspection.

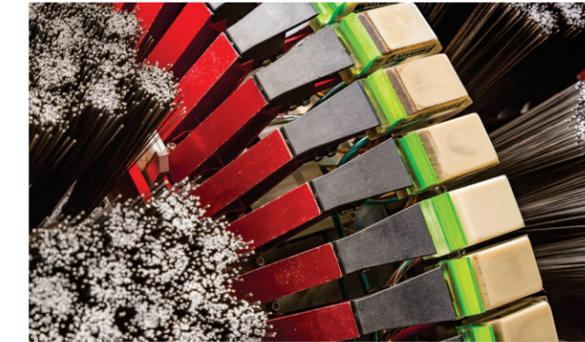
Pinhole corrosion

Very small pinholes can cause major problems—leaks. Whether caused by external microbe-induced corrosion or internal pitting, pinholes are always extremely difficult to detect. Our highest-definition tools have the capability of detecting pinhole-sized features, and seeing the most minute areas of metal loss. VECTRA HD, for example, has industry-leading sensor resolution, and yields multiple data sets in a single run—resulting in a sharper view that more accurately locates, identifies, and sizes complex anomalies such as pinholes. On top of inspection tool capabilities, we're constantly improving our algorithms and models so our analysts can more accurately quantify these difficult features. All in all, your advantages are reduced maintenance costs and less lost revenue, in exchange for increased uptime, fewer digs, and improved safety.

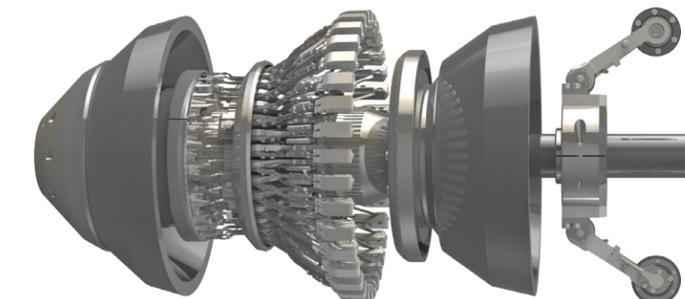
CPIG is ideal for pipelines with low pressures, dual diameters, or otherwise complex geometries—running effectively in many pipelines previously considered unpiggable. Available for diameters of 4 in. to 42 in., CPIG can navigate multiple 1.5D back-to-back bends, and bore reductions up to 25%. In many cases, it eliminates the need for modifications to the pipeline, launcher, or receiver. As well as providing a high level of detection and accuracy, the tool greatly streamlines logistics and costs by combining metal-loss, caliper, and inertial data in one run. It's ideal for dual diameters across the fleet range.

Whether an operator is looking for reliable baseline surveys or routine inspections, our MagneScan HR & SHR and CPIG fleets continue to be among the go-to solutions for most customers around the world. Both fleets provide accurate and reliable corrosion inspection, which enables the integrity management programs of most pipeline operators. Robust designs and extensive track records result in industry-leading first-run success rates; and they also have a combination of inspection options. Geometry and pipeline mapping can be added to a metal-loss inspection to simplify operations. Furthermore, the latest-generation MagneScan tools provide an additional option to increase detection and sizing specifications, which are particularly valuable for pipelines with higher incidence or complexity of corrosion.

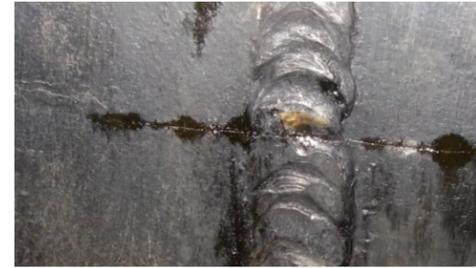
Girth weld cracking

Cracks in girth and spiral welds have been causing operators concerns for a number of years; but finding a reliable inspection solution has been challenging. Advancements in our MagneScan and VECTRA technologies have led to increased confidence levels in detection and sizing of these features with MFL technology. We've gathered a large database of actual pipeline defects, alongside manufactured defects, to develop a bespoke analysis process and associated report specifically for girth and spiral welds. This is now proven to be a reliable solution for operators who know they have pipeline construction concerns, and need to better focus their integrity and maintenance budgets.

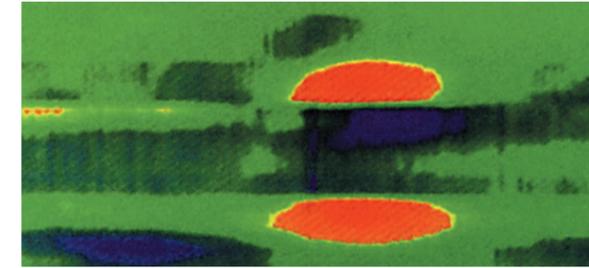
Axially oriented seam corrosion

For over 20 years, our **TranScan™** inspection fleet has been the industry go-to for detecting seam-weld defects, axial flaws, and third-party damage. TranScan's transverse field inspection (TFI) technology ensures that axial flaws (cracks and elongated metal loss) present their largest dimension to the magnetic flow, creating a strong signal from flaws that are invisible to other magnetic tools. TranScan tools are very robust, and equally at home in gas or oil pipelines. They can inspect up to 4 m/s and have a high tolerance to dirt and wax. They have even been used to detect flaws in seam welds as narrow as 0.1 mm. TranScan has become the tool of choice among operators and regulators for the detection of hook cracks and lack-of-fusion in pre-1970 ERW gas pipe. Its sensitivity to dents, associated cracking, and metal loss also makes it ideal for the detection and classification of third-party damage.

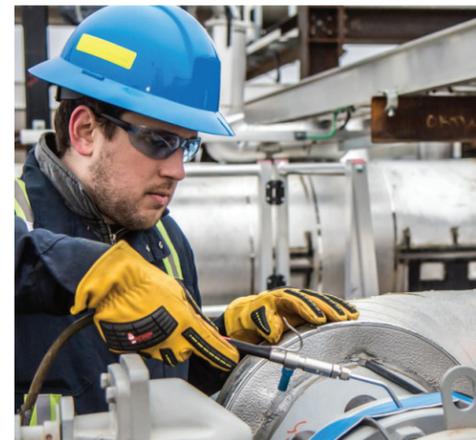
Corrosion management and response planning

It's industry standard to compare data from different inspections to determine corrosion growth rate, but the application of the resulting information is not well understood. By contrast, our **RunCom™** product provides a range of corrosion-growth and integrity-assessment services that support response-planning decisions. By moving away from fixed corrosion rates to instead use joint-based and cluster rates, we leverage the real power of RunCom's signal-level data analysis—this significantly increases the precision of growth-rate calculations, and improves decision-making about re-inspection intervals and repair initiatives. With excavation and repair costs typically \$100,000, RunCom's ability to avoid unnecessary digs has very clear value.
