THE DYNAMICS OF A VERTICAL PUMP

By Tom Spettel
Customer Training Manager

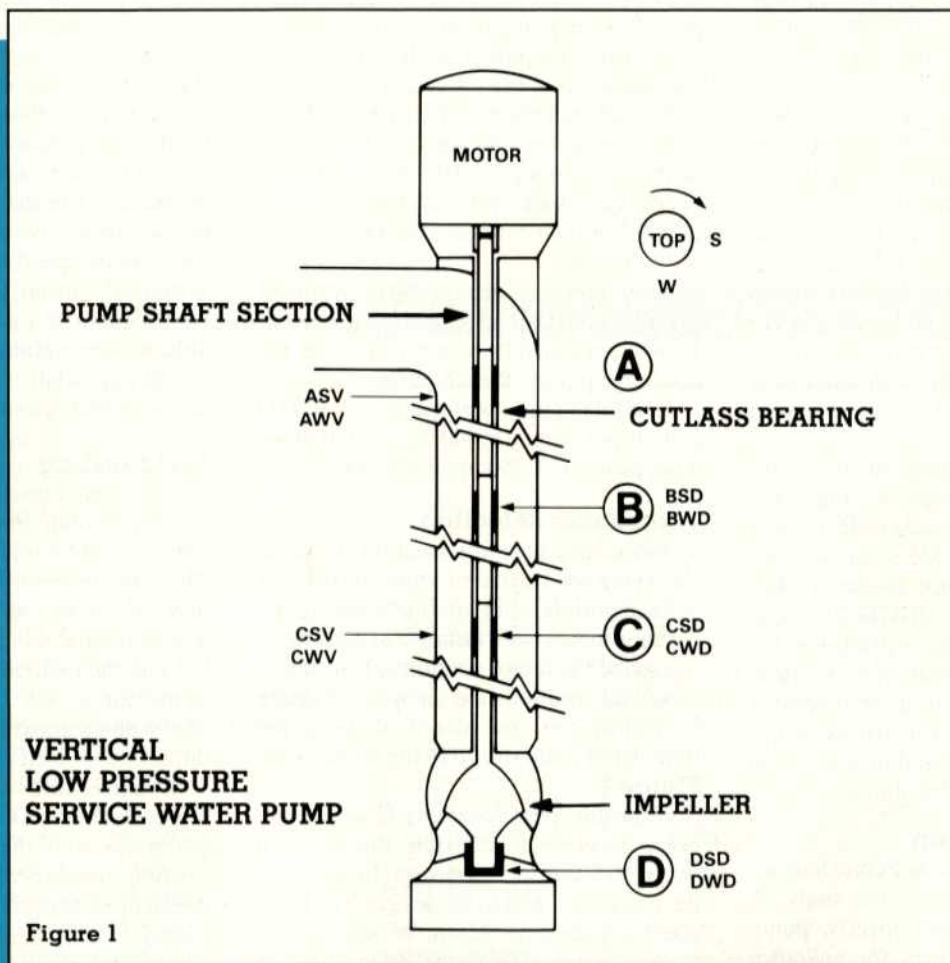
Figure 1

A drawing of the pump and motor is shown in Figure 1.

Since very little information is available on the rotor dynamic characteristics of vertical pumps, both proximity and velocity transducers were installed at each bearing and at the motor coupling. Transducer mounting locations are shown in Figure 1. Transducers are identified using the three-letter code shown in the legend with Figure 1.

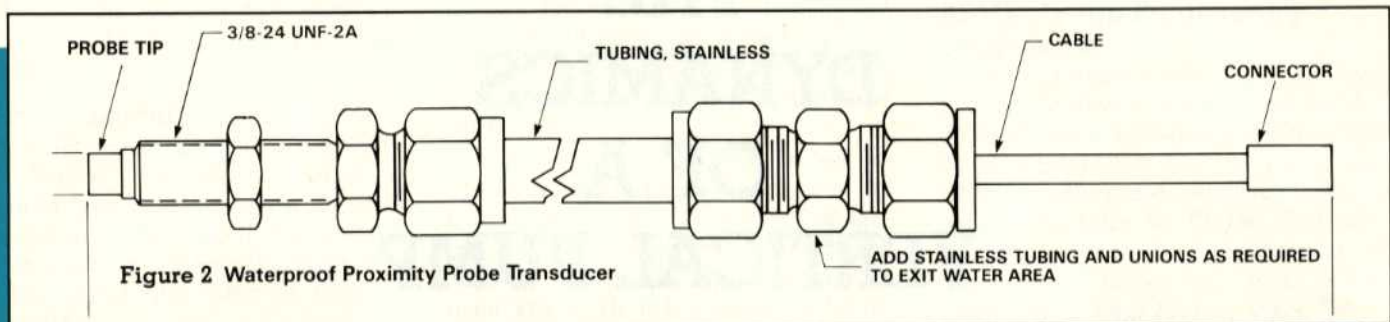
Figure 2 Waterproof Proximity Probe Transducer

Transducers at locations C and D are below river level, dictating the use of a waterproof transducer design. In addition, the transducer had to be designed to withstand the abrasive action of sand in the flowing water. The probe design used is shown in Figure 2.
