Case study: Norway

# Mechanical pipe cutter tool frees premier packer in Norway

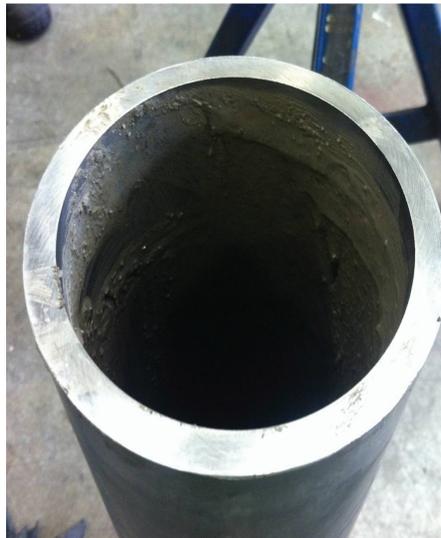
The recovered packer and stuck tubing after the MPC cut.

In less than 25 minutes, Baker Hughes used the MPC tool to cut the tubing and safely recovered the entire tubing and packer from the well. The team made six cleanup trips capturing debris from a damaged swab cup tool before running a new IWS completion with a flawless installation delivering substantial savings to the client.
